Consolidation Coal Emery Mine Subsidence Report for May 2007

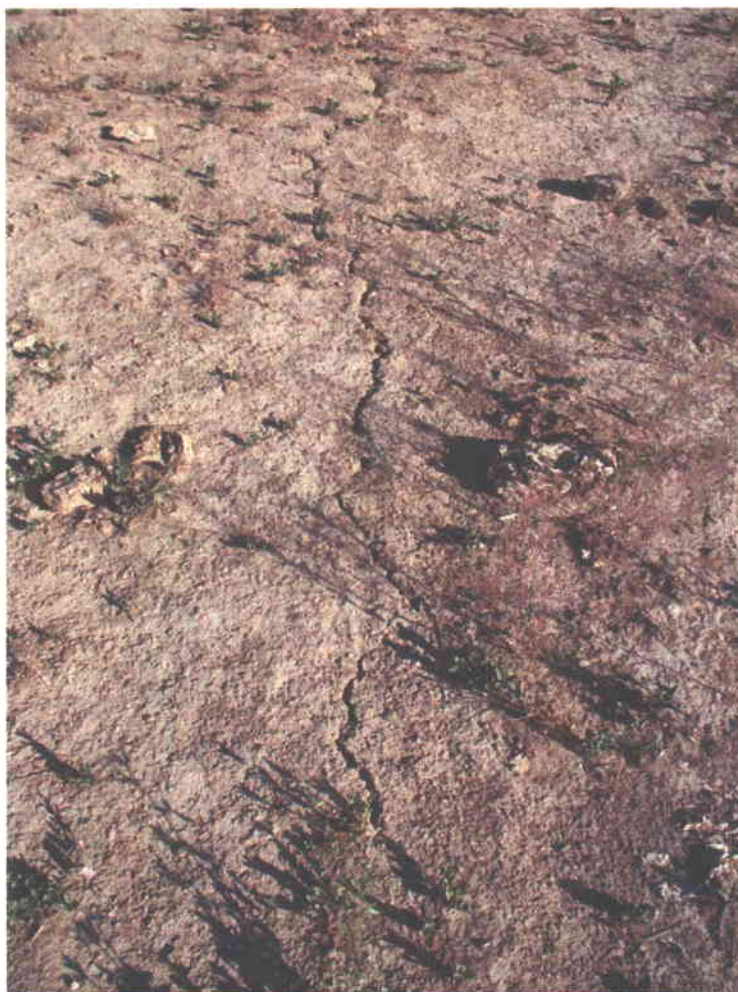
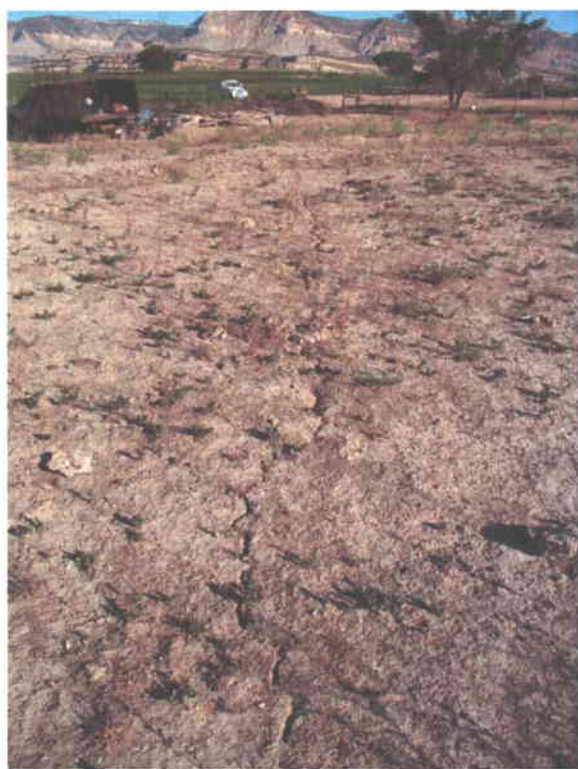
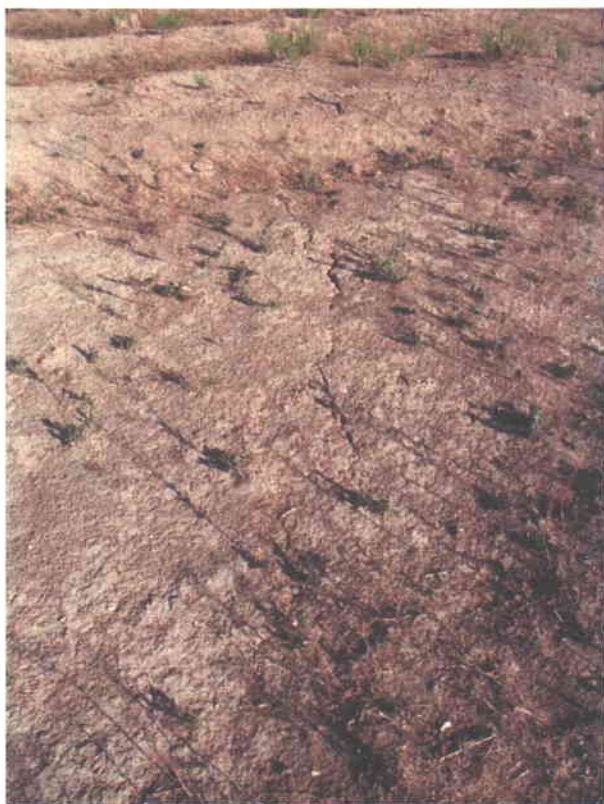
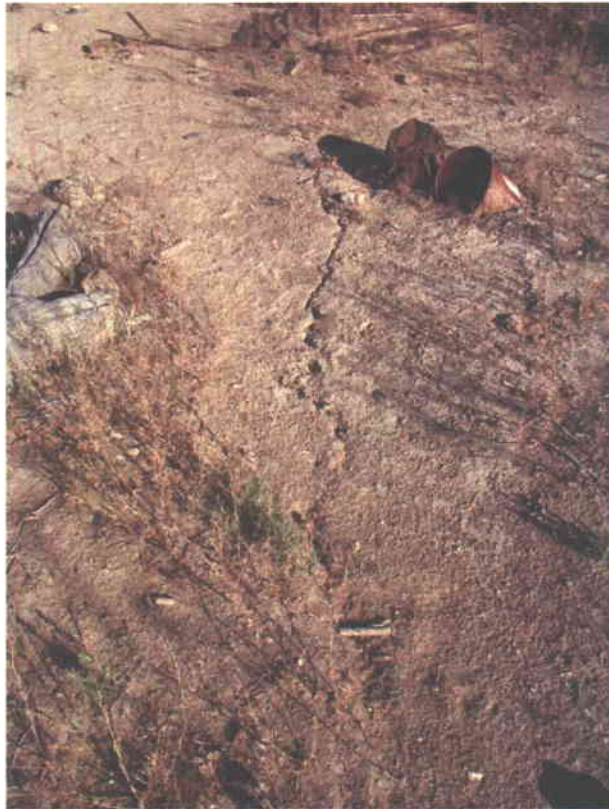
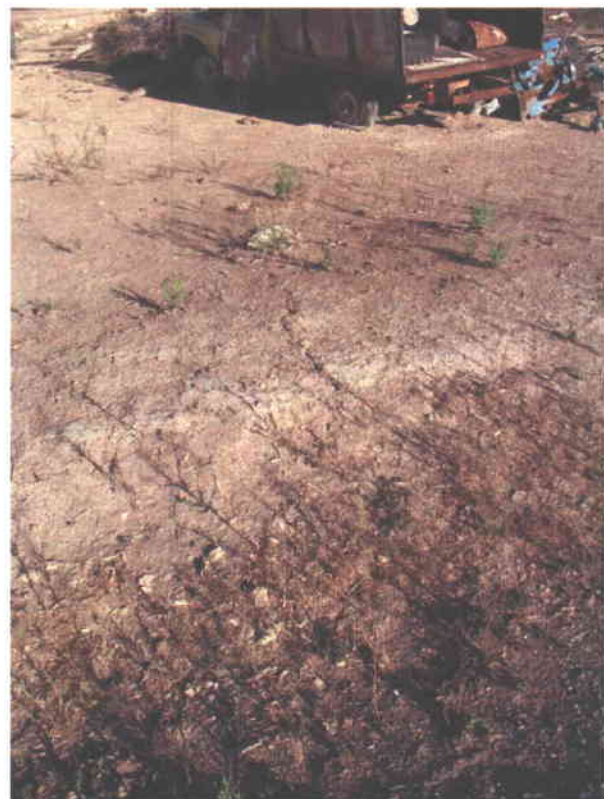
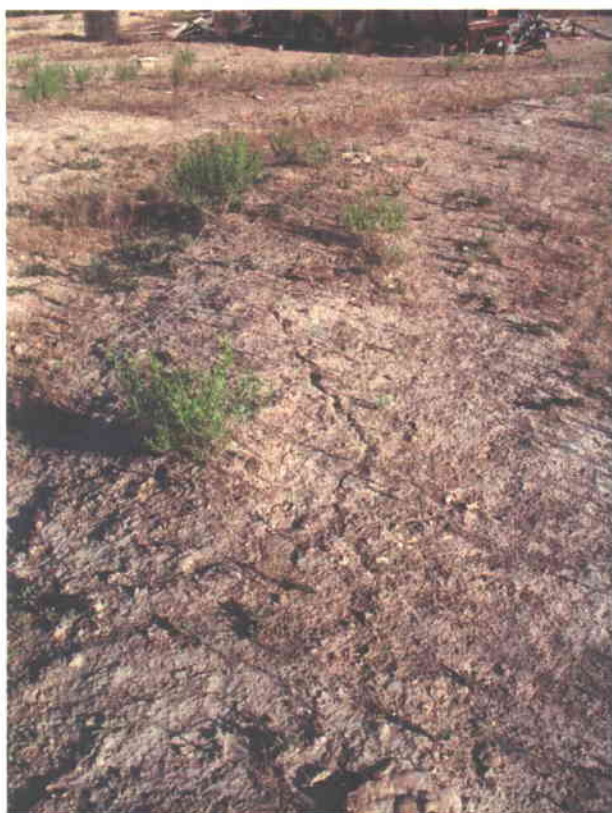
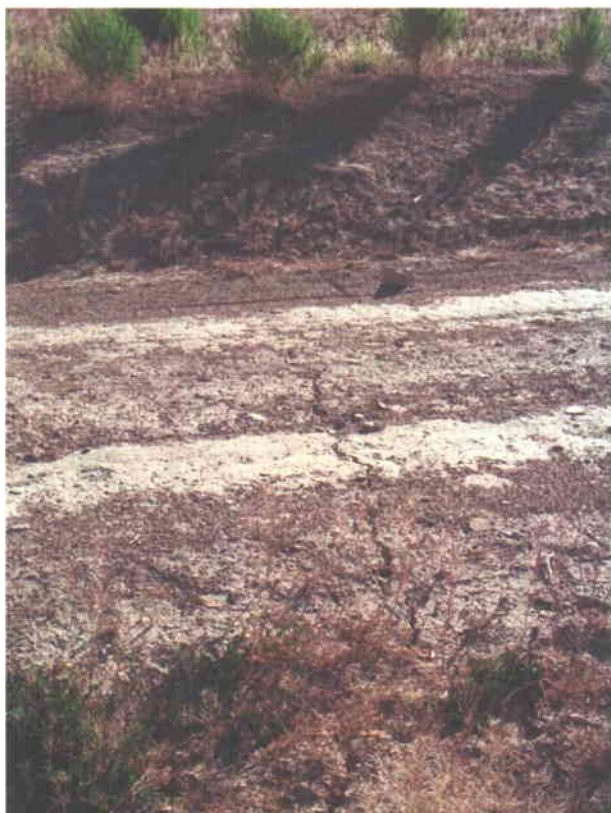
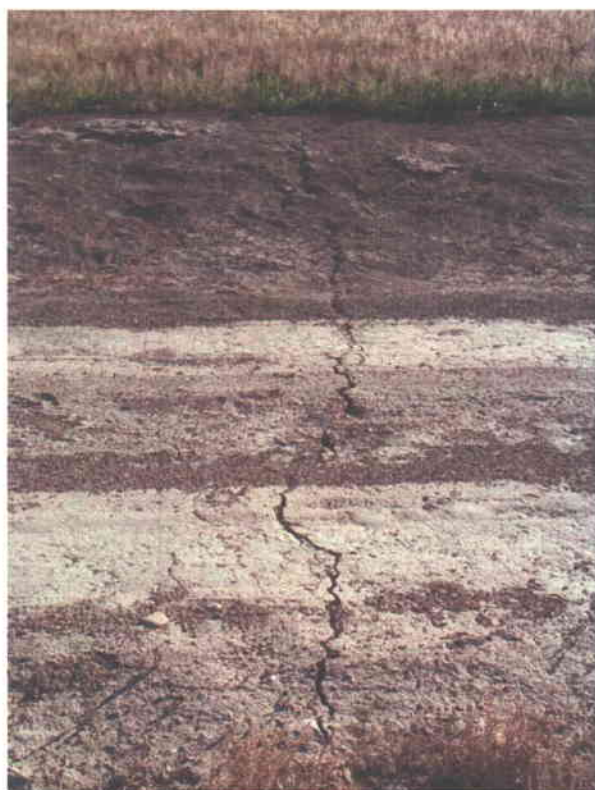
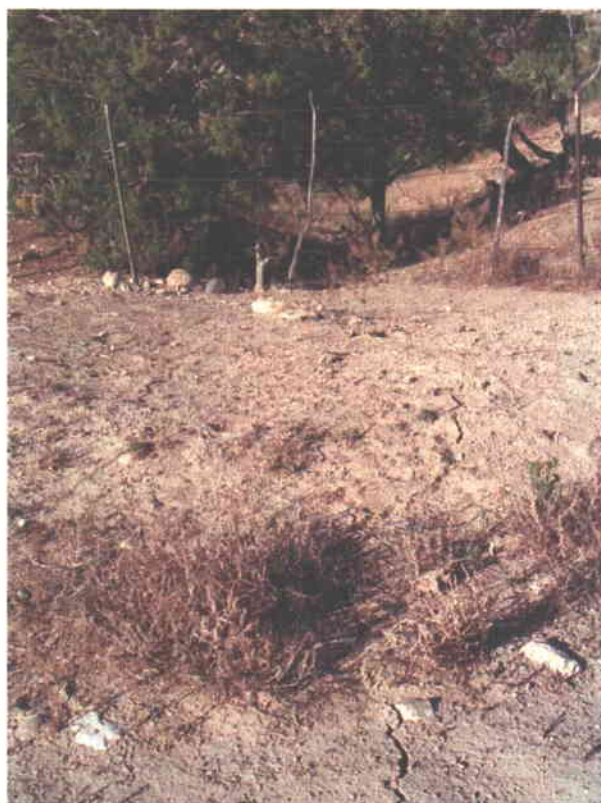
6-8-07

Few cracks over Panel 14 West pictures were taken. PB
